3M ESPE

Making Better Impressions

Trouble

Guide

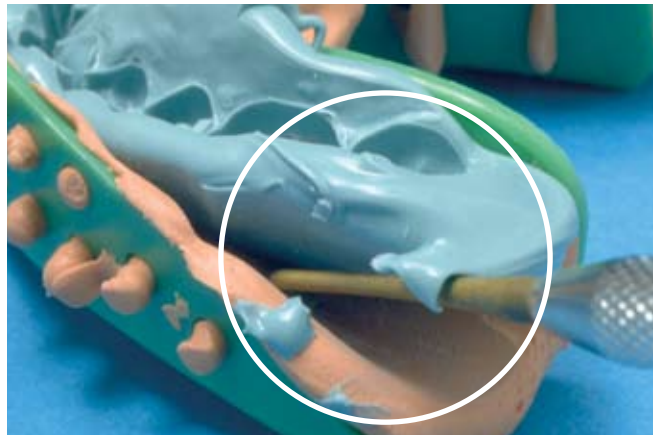
Visual Appearance: Heavy body and light body materials not blended, or mixed together.

Result: Restoration will not seat or fit properly.

Exceeding the working time.

Impression material stored at elevated temperature.

Sulfur or acrylic contamination of pre-set heavy body material in two-step technique.

Poor Bond Between Heavy Body and Light Body Material

Follow manufacturer's working time specifications.

Choose material with longer working time.

Store impression material at room temperature.

Avoid contact with sulfur contaminants:
Wear gloves proven not to contain traces of sulfur.

Avoid contact with acrylic and methacrylic contaminants: Ensure impression material does not come into contact with methacrylate residue from acrylate temporary materials.

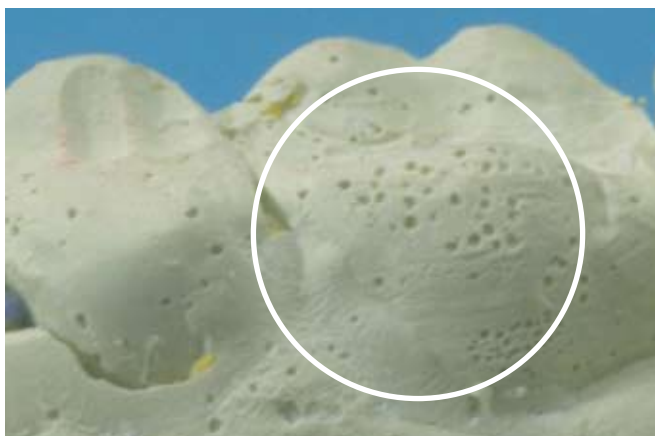
Hydrogen gas emission.

Stone Model with Hydrogen Evolution Voids

Follow manufacturer’s instruction for casting time.

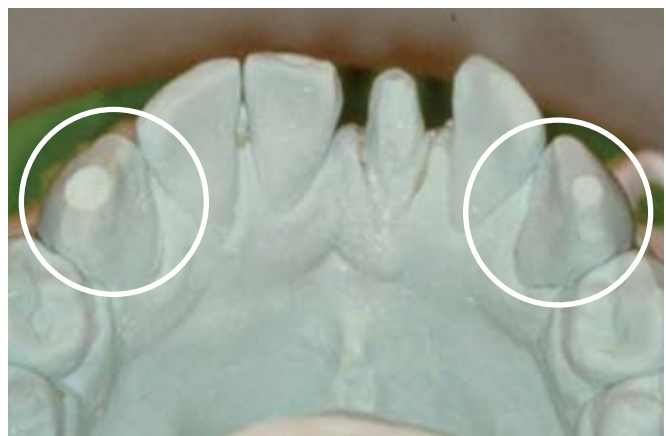
Visual Appearance: Voids on margin, powdery cusp tips on incisal edges on prepared tooth. “Golf-ball” appearance of stone model.

Tooth contact with impression tray, or gauze of double bite tray causes water to leach out of the tray, dehydrating the stone.

Stone Model with Powdery Cusp Tips

Instruct patient to bite passively in centric occlusion when using dual arch trays.

Fill tray with sufficient amount of material.
